### **Akaroa Wastewater Project – Report on Thacker Property Inspection**

Please find set out below our report of an initial walkover of the 114ha Thacker property in Robinsons Bay on Wednesday 25<sup>th</sup> of January 2017.

# Appendix A: Thacker Irrigation and Potential Pond Storage Layout Plan

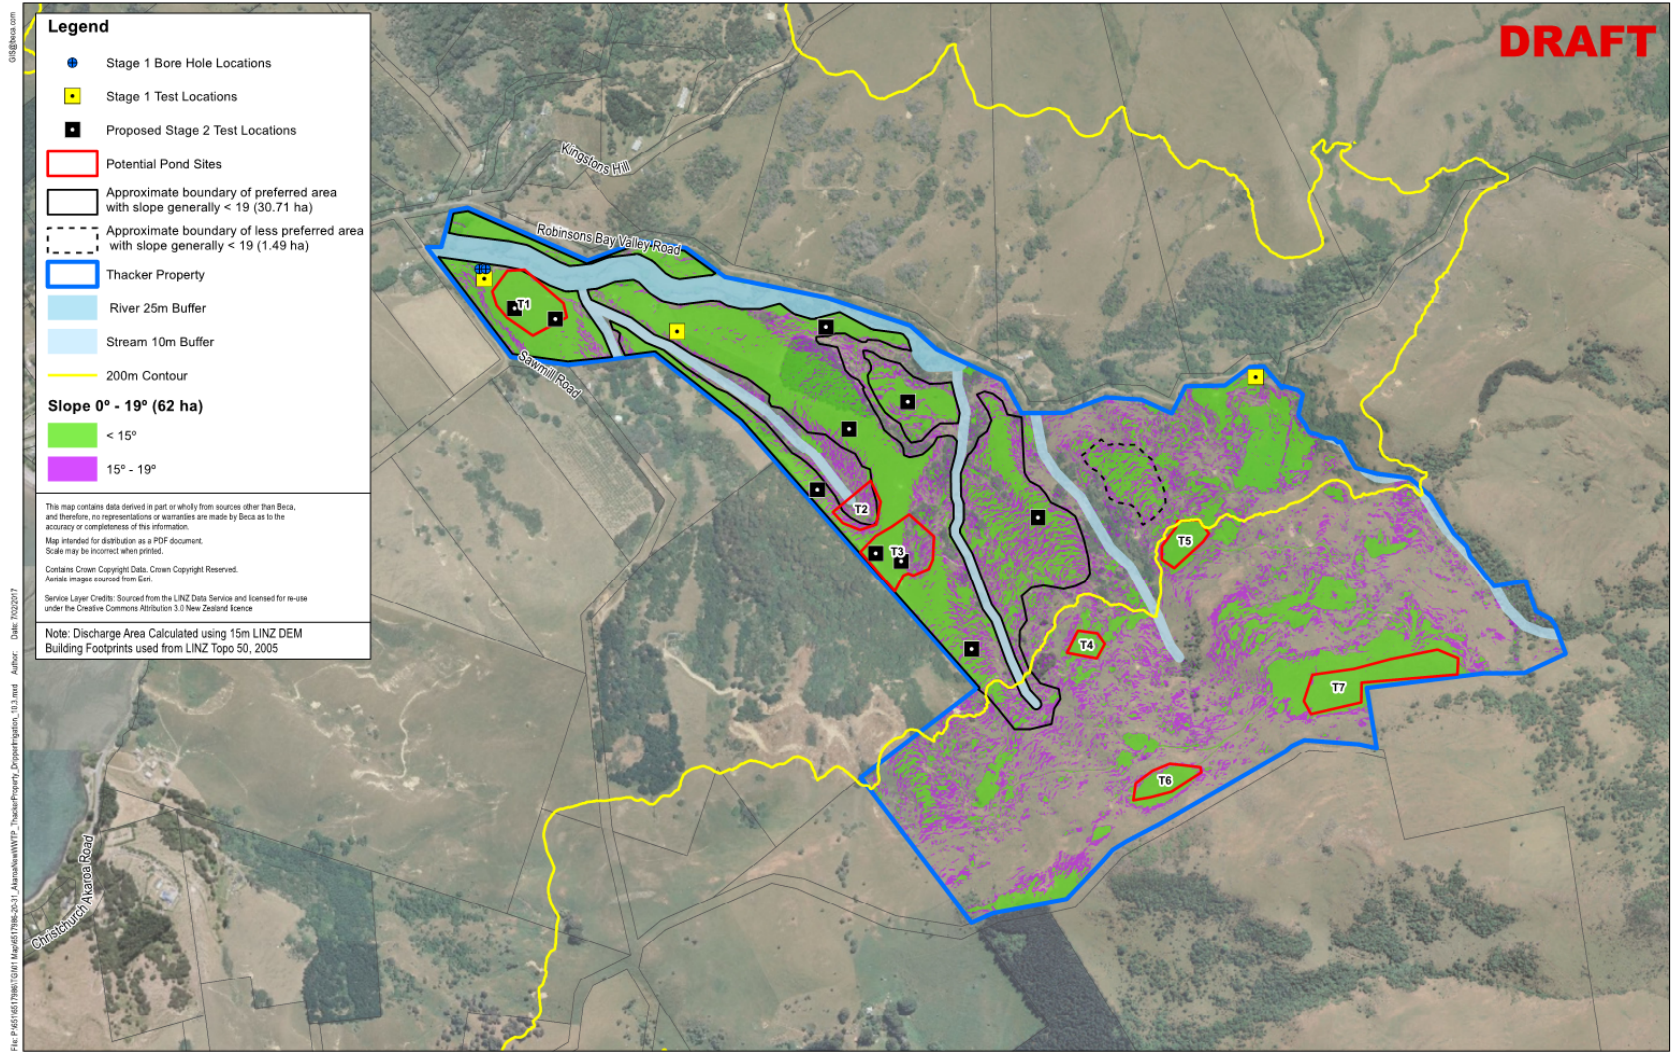
Following the site inspection a draft of the potential irrigable area and potential pond storage locations has been developed. This is provided in Appendix A. The plan employs a number of criteria for selecting potentially irrigable land, and for section of potential storage pond sites. These are set out in Tables 1 and 2 overleaf.

A preliminary assessment is that the increased risk of instability caused by irrigation of preferred areas within the site is low. This is based on applying dripper irrigation to the lower areas and mid-areas as shown in Appendix A, where the application is set back from steeper features such as gullies and away from hummocky ground above steeper slopes.

The Appendix A plan shows pond sites viewed during the walkover. The selected sites all conform to the proposed minimum dwelling buffer distance of 100m<sup>1</sup>. A commentary on the visual observations and recommendations of these potential pond sites is set out below.

- 12 test pits to 4m depth minimum at locations shown on the layout plant in Appendix A
- A smaller number of infiltration tests at selected areas
- Hand augers to 1.8m depth at intermediate sites between the test pits

Based on the observations the land below the 200m contour appears to be suitable for irrigation with appropriate buffer separation to streams and the gullies, subject to confirmation of its technical suitability on other grounds. It is recommended that field investigations are concentrated on these lower slopes to confirm the irrigation feasibility.

It is recommended that to characterise the soil and sub-soil conditions on the property (and particularly on the land below the 200m contour) that test pits are dug and further infiltration testing be carried out (subject to what is observed in the test pits). The test pits should be excavated to a depth of at least 4m to ascertain
